Bulletins > TSB 19-2039: 2019 Ranger - Power Fold Mirrors – Power Fold Mirrors Inoperative (Effective Feb 18 2019)

TECHNICAL SERVICE BULLETIN		19-2039
Power Fold Mirrors – Power Fold Mirrors Inoperative		15 February 2019
Model:		
<div>Ford 2019 Ranger</div>		
Issue: Some 2019 Ranger vehicles equipped with power fold mirrors may exhibit inoperative power fold mirror functions. This may be due to the mirror switch sticking in the bezel. To resolve the condition, remove the switch and retighten the mounting screws.		
Action: Follow the Service Procedure steps to correct the condition on vehicles that meet the following criteria:		
<ul style="list-style-type: none">• 2019 Ranger		
Labor Times		
Description	Operation No.	Time
2019 Ranger: Inspect And Remove Mirror Switch, Test Operation And Reinstall Following The Service Procedure (Do Not Use With Any Other Labor Operations)	192039A	0.3 Hrs.
Repair/Claim Coding		
Causal Part:	2104481	
Condition Code:	41	
Tool List		
Drive	Tool Name	
1/4"	Power Tool

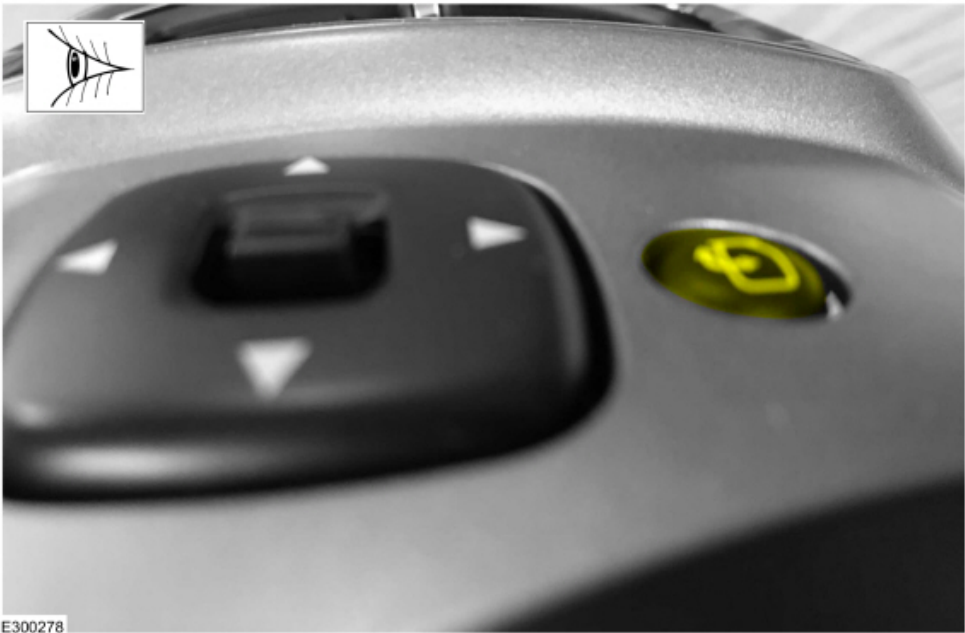
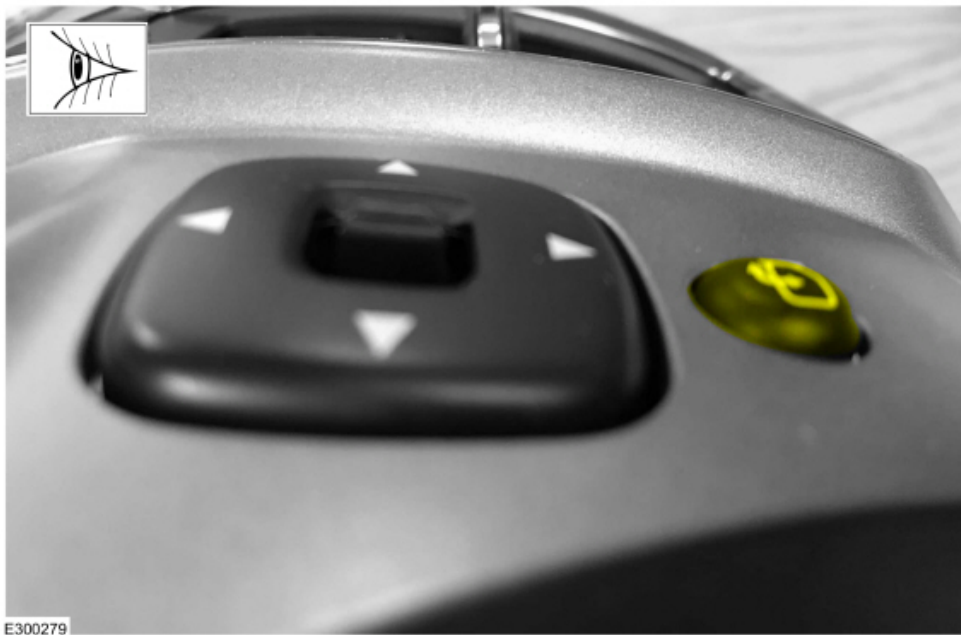
1. Inspect the round button above the 4-way mirror adjuster. The button will protrude approximately 2.5 mm (3/16 in.) when the mirrors are in the extend position. The button will be almost flush with the left side instrument panel trim panel when the mirrors are in the fold position. Does the switch operate in both positions? (Figures 1-2)

- (1). Yes – this article does not apply. Refer to Workshop Manual (WSM), Section 413-01 for normal diagnostics.
- (2). No – proceed to Step 2.

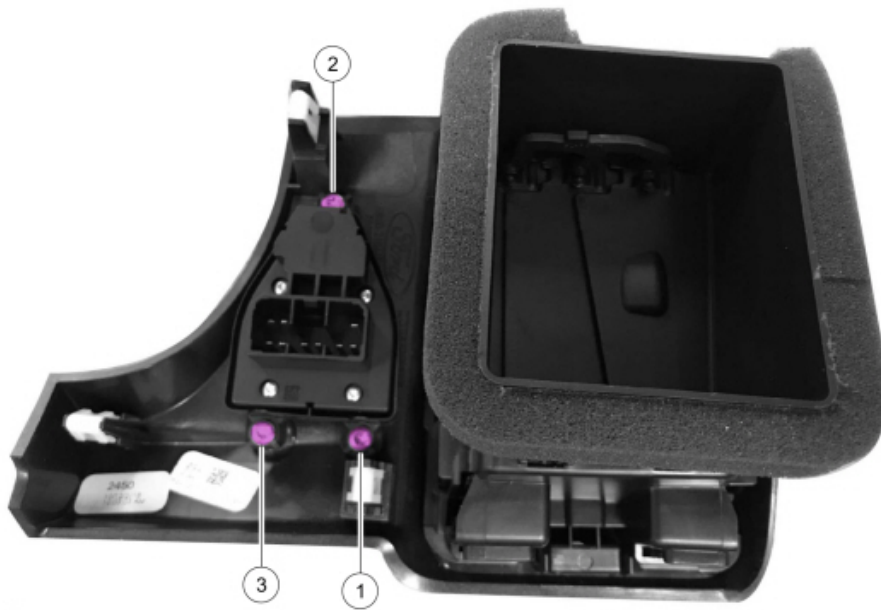
Figure 4

3. Remove the 3 screws and remove the switch from the left side instrument panel trim panel. With the switch removed and electrical connection plugged into the switch, test the mirrors for proper operation. Do the mirrors fold and extend properly? (Figure 4)

4. Reinstall the switch in the left side instrument panel trim panel. Tighten the screws in the following order, tighten all screws to 1.1 Nm (10 lb-in). (Figure 4)

- (1). Bottom inboard
- (2). Top
- (3). Bottom outboard
